NASA Technical Memorandum 104743

# Long-Term Corrosion Evaluation of Stainless Steels in Space Shuttle Iodinated Resin and Water

Douglas D. Krohn

January 1992

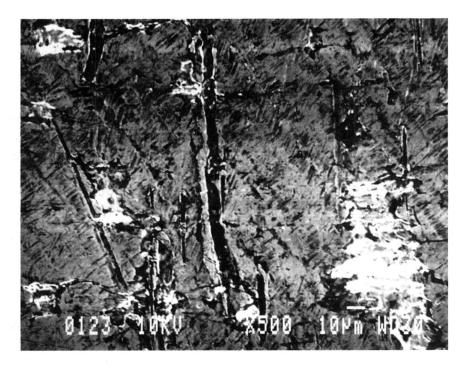
5.2.2.1.1 <u>SEM analysis</u>. Figures 2 and 3 show the outer and inner surfaces, respectively, of the 316L specimen. The outer surface has a rougher surface finish than the inner surface. This was apparent on all three specimens examined and is probably a result of the tube extrusion process. Since a reference specimen from the original tube stock was not found for the 316L, a comparison could not be made between its finish and that of the original material. The outer surface had scratches that ran longitudinally with the tube axis. These markings were probably due to the drawing process used to manufacture the tube. The presence of these markings indicate that the level of corrosion has been small enough not to change the original surface finish.

Fig. 2. Aqueous iodine exposure - SS 316L O.D. SEM at 500x.

Fig. 3. Aqueous iodine exposure - SS 316L I.D. SEM at 500x.

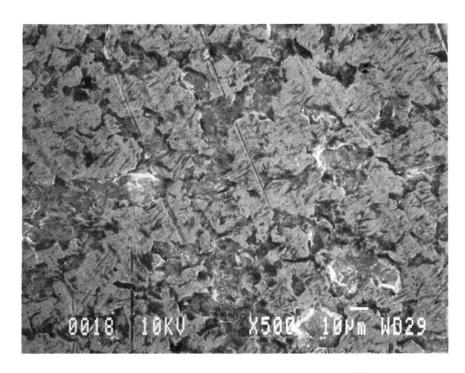
Figures 4 through 7 show a comparison of the 321 exposed specimen surfaces to the reference specimen. The outer surface of both the test and reference specimens are similar in nature. Both have scratches that run longitudinally with the tube axis. As with the 316L, the origin of these marks probably resulted from the tube drawing process. The level of corrosion due to its exposure in iodinated water was relatively small since these markings are clearly present on the surface of the test specimen.

Fig. 4. Aqueous iodine exposure - SS 321 O.D. SEM at 500x.

Fig. 5. Reference specimen - SS 321 O.D. SEM at 500x.

Fig. 7. Reference specimen - SS 321 I.D. SEM at 500x.

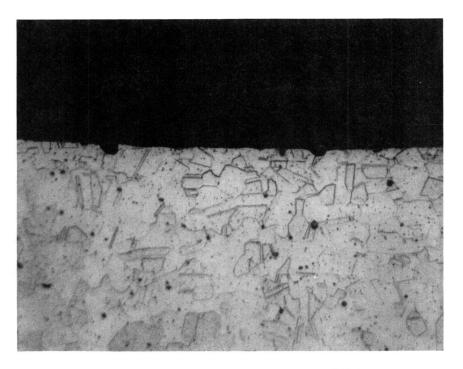
5.2.2.1.2 <u>Metallography analysis</u>. Figures 12 through 16 are micrographs of metallography performed on each alloy. They show areas in which pits were found. The majority of the cross-sections were relatively free of pitting. No observable difference was found between the inner and outer surfaces. The pits shown do not penetrate past the first grain boundary layer. In addition, both test and reference specimens have similar surface roughness. This is an indication that a minimal level of corrosion has occurred. Furthermore, the grain structure does not indicate the presence of intergranular corrosion.

Fig. 12. Aqueous iodine exposure - SS 316L sectioned metallograph at 400x.

Fig. 13. Aqueous iodine exposure - SS 321 sectioned metallograph at 400x.

Fig. 14. Reference specimen - SS 321 sectioned metallograph at 400x.

Fig. 15. Aqueous iodine exposure - SS 347 sectioned metallograph at 400x.

Fig. 16. Reference specimen - SS 347 sectioned metallograph at 400x.
